MERRIMACK RIVER BASIN
ASHLAND, NEW HAMPSHIRE

SQUAM LAKE DAM
NH 00059

PHASE I INSPECTION REPORT
NATIONAL DAM INSPECTION PROGRAM

DTIC FILE COPY OCTOBER 1978

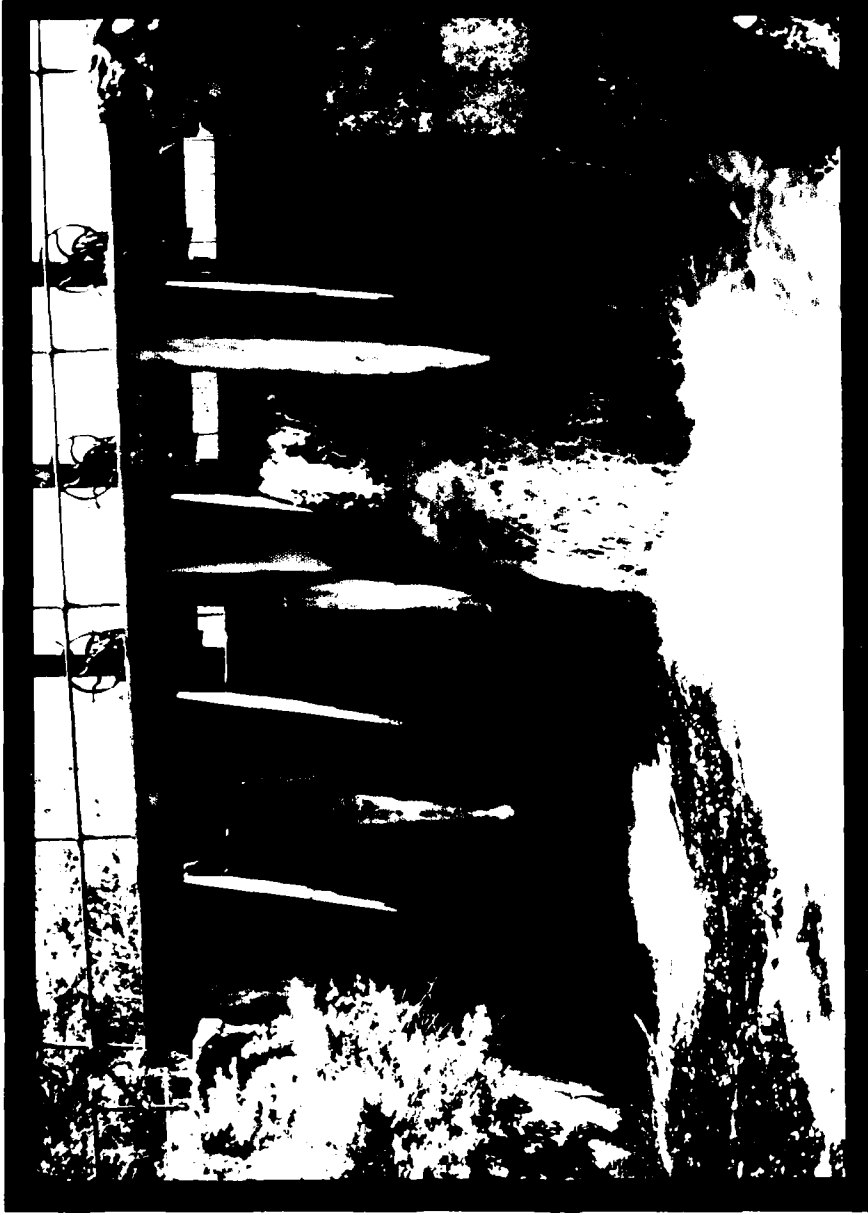
View of the spillway section showing the permanent concrete weir and the stop planks surmounting the ogee crest. The low level outlets are submerged below the tailwater level directly beneath one of the three visible piers. Stone works on right of picture dates back to original construction in 1856.

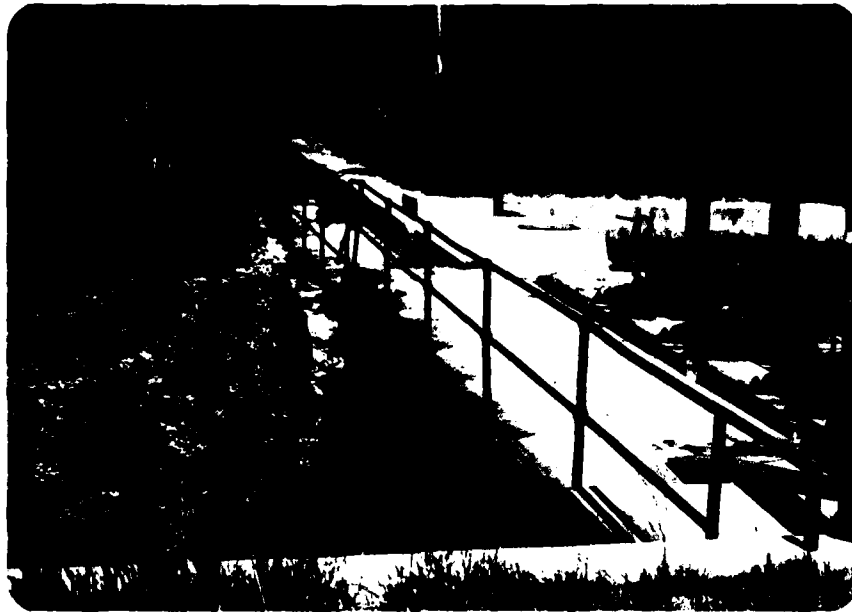
Photo 1 - View of the dam taken from the left abutment, looking toward the right abutment. The spillway section is in the foreground, showing the sluice gate hoists and the stems of sluice gates. The right abutment non-overflow section is in the foreground.

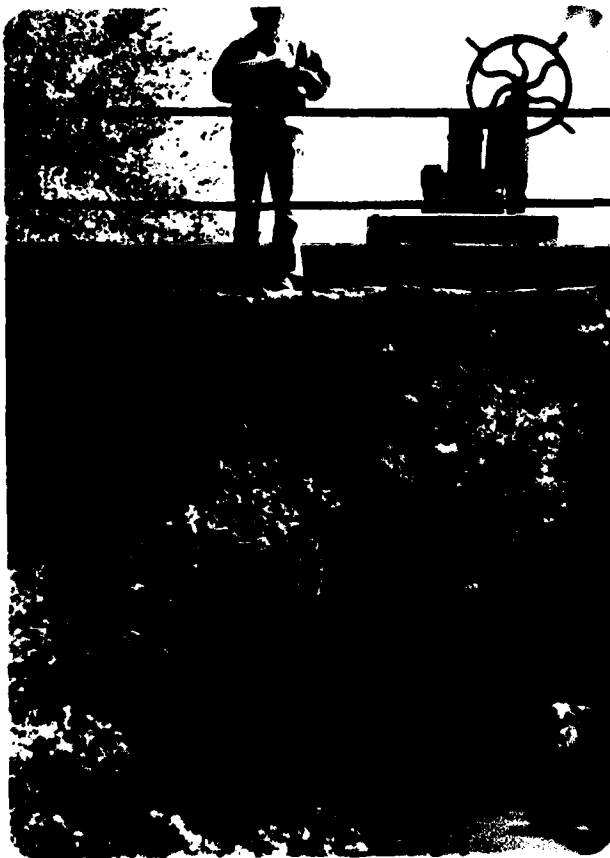
Photo 2 - View of the right abutment non-overflow section from downstream. The original masonry wall is visible in front and the new concrete parapet wall is in the background. The 66-in. diameter abandoned penstock and its gate hoist are visible at the picture's right.

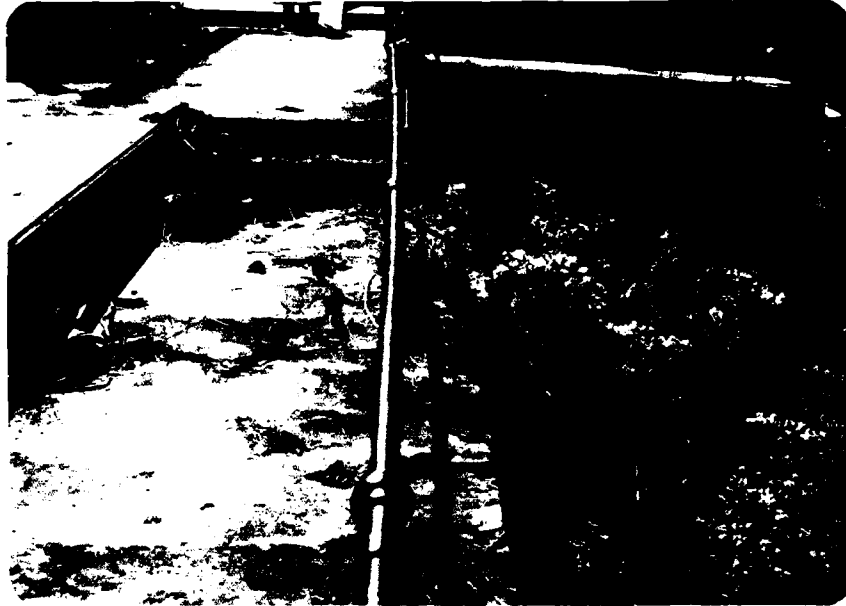
Photo 3 - View of the dam from the right abutment showing old and new non-overflow sections and the relation to the spillway walkway elevation.
